Non-conformities and their consequences

M. Giovannozzi

Non-conformities for sector 5-6 - I

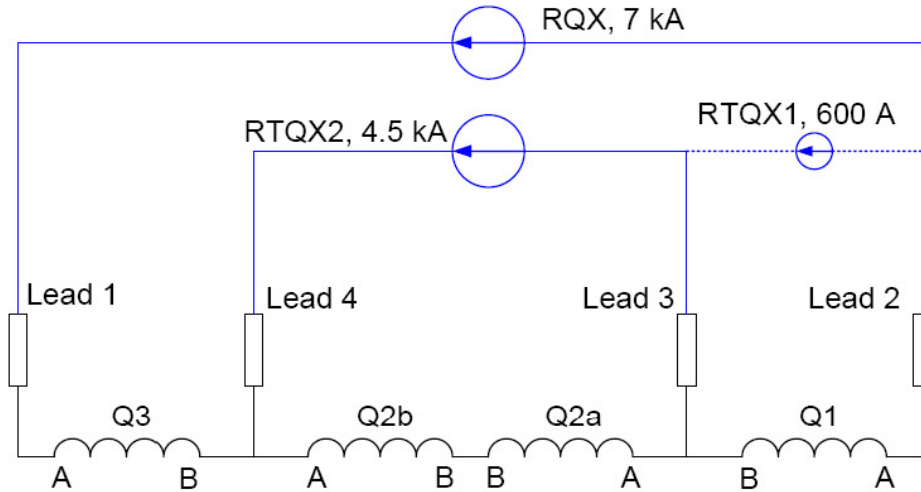
Electrical Layout v.6.501

- Two main issues:
 - MCBCV10.L6.B1 (comments by A. Siemko): problem with its protection. One voltage tap is lost. Some extra tests should be performed to assess whether:
 - Repairing action possible
 - Limit current
 - Triplet quadrupoles (and correctors) polarity error (comments by S. Russenschuck): known and systematic error (e.g., MQSX). Only solution is to change the polarity at the level of the patch panel. Presentation at the MPP given (14/04/08).

From NC report.

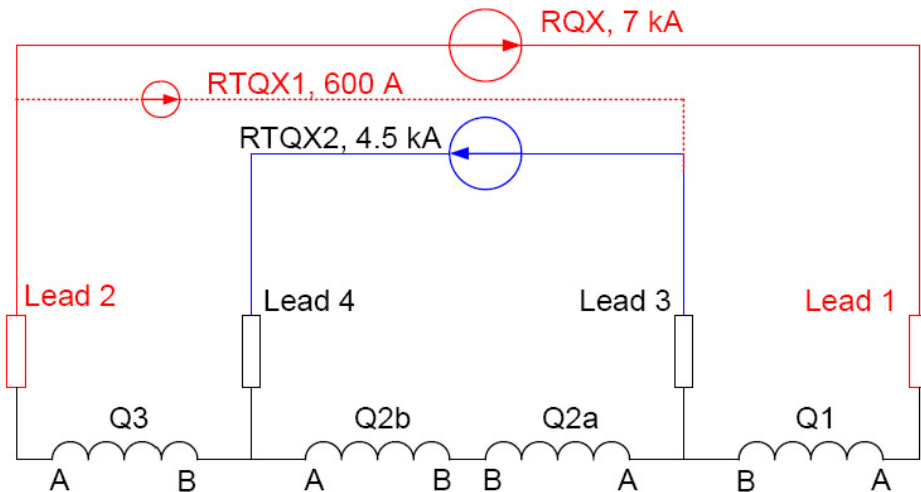
Machine assembly
Position of the current leads and polarity given according to the measured sequence of voltage-taps
