Plug-in Modules in 7-8 Status report

P. Strubin on behalf of AT-VAC

Extent of the problem in 7-8

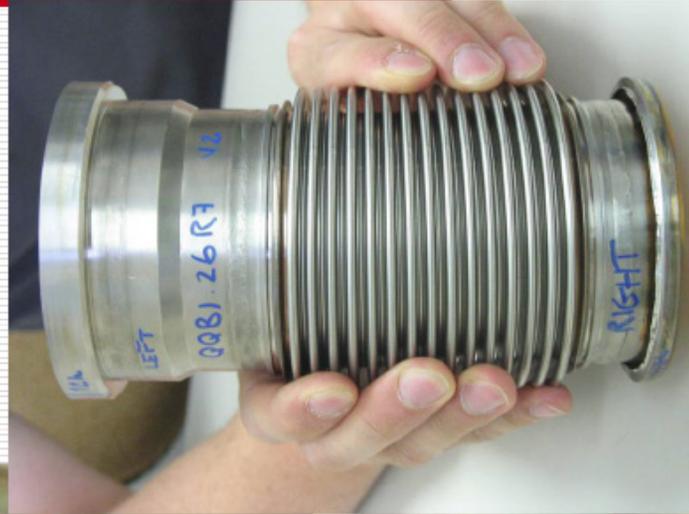
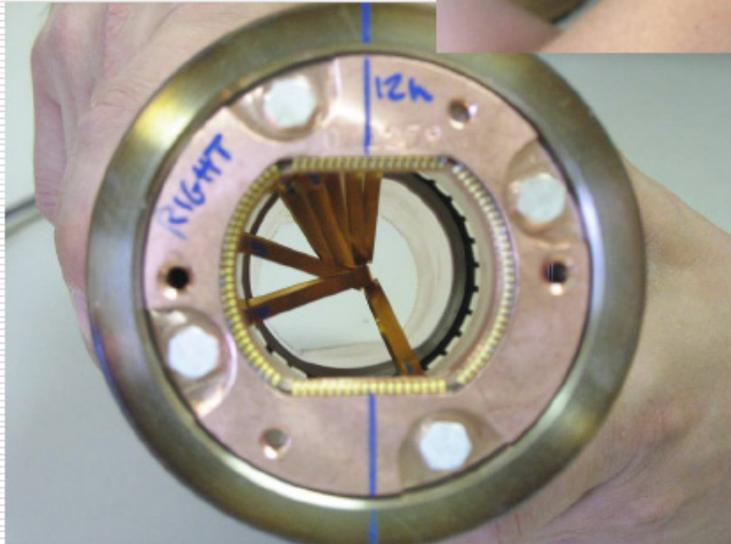
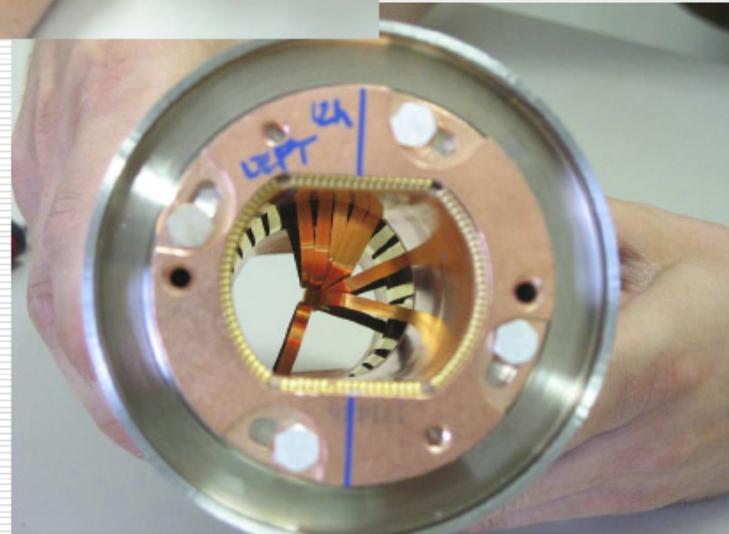
QQBI.26R7 line V2

QQBI.26R7 V2 Bends done by the copper tube

- ❑ Fingers have not come out of guiding tubes
- ❑ This implies that damage was done during warm-up

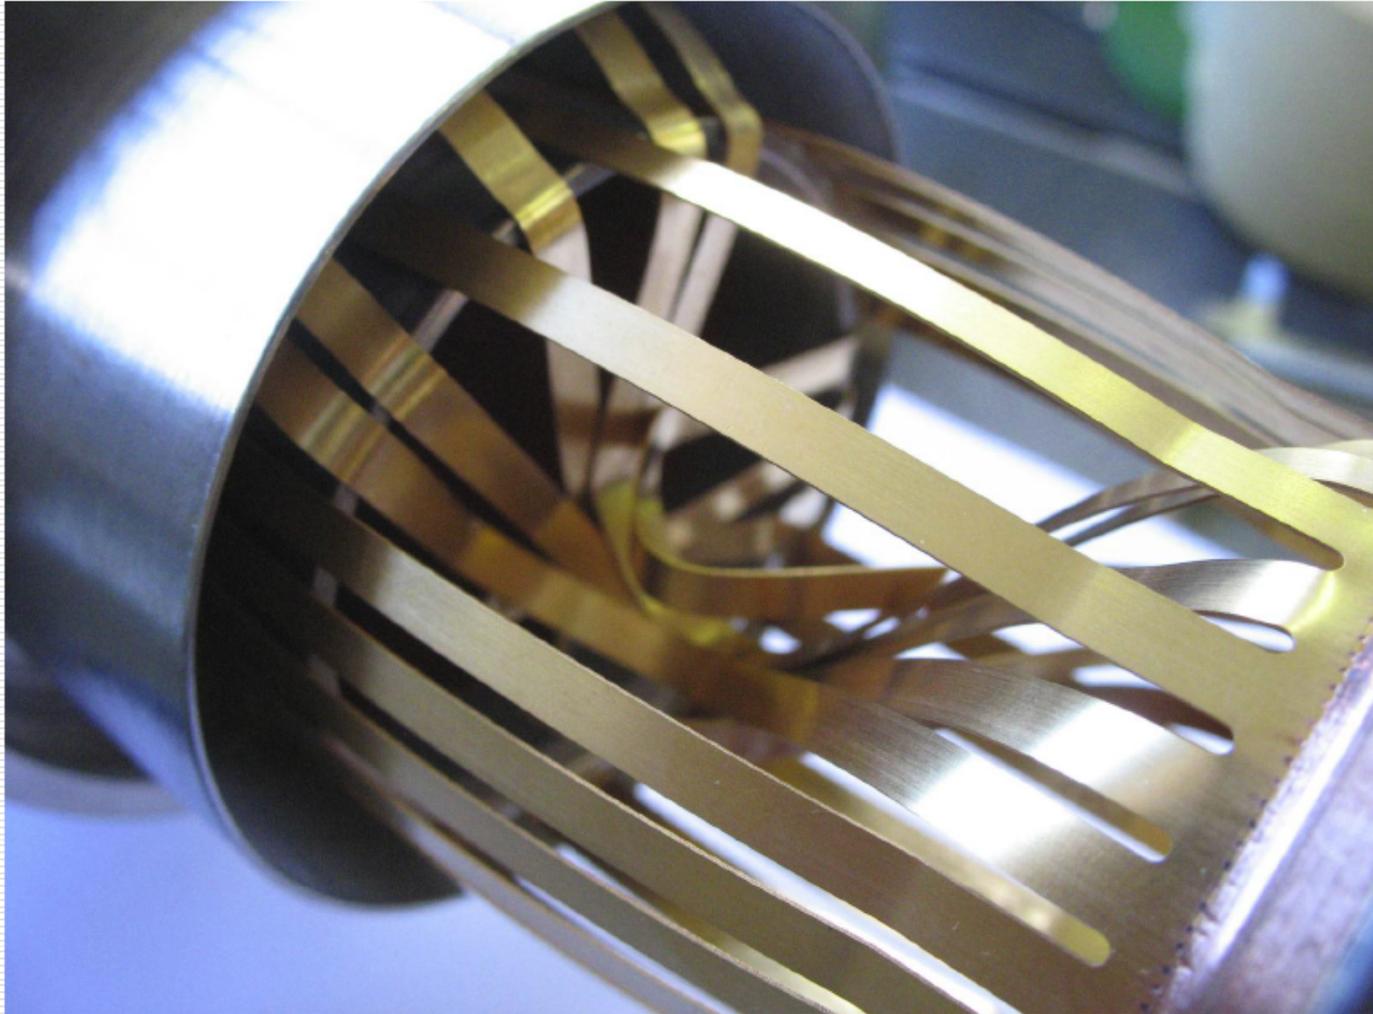
Failure reproduced in lab

Same deformations as in sector 7-8

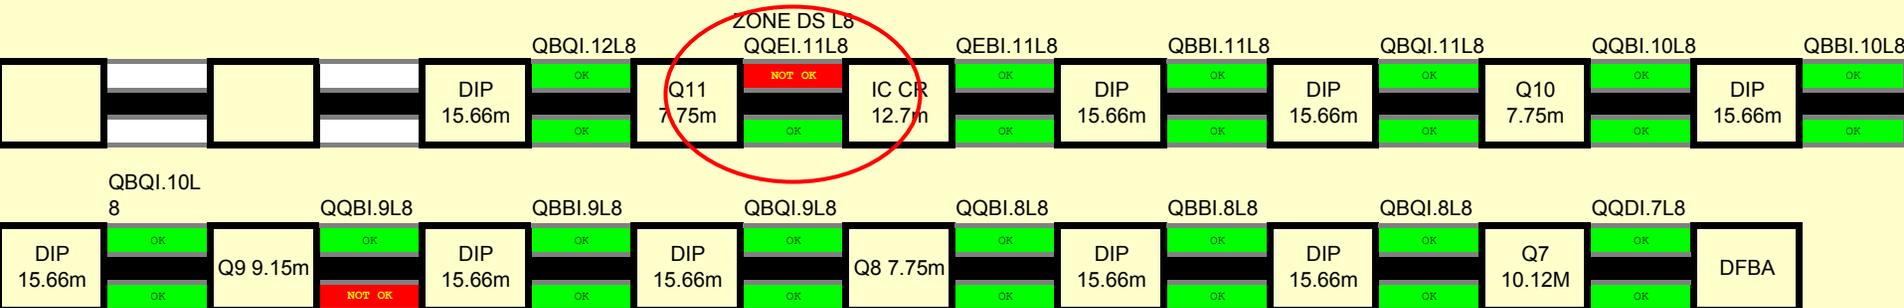
Only unexpected failure in DS

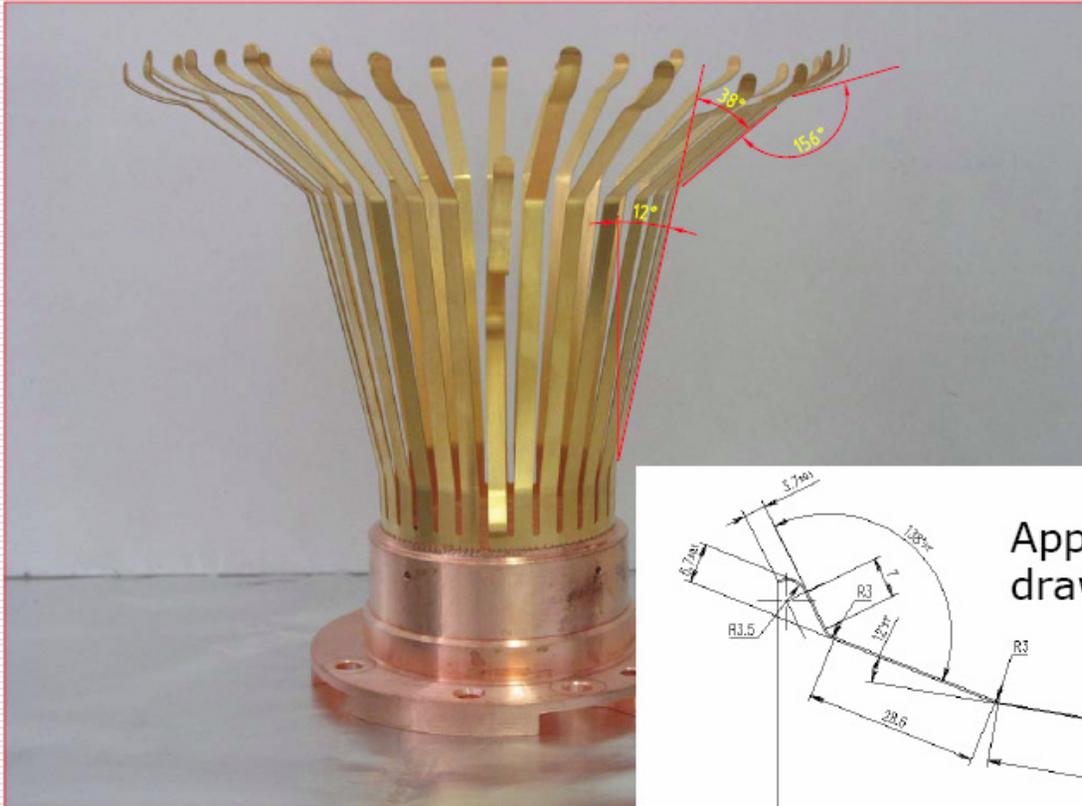
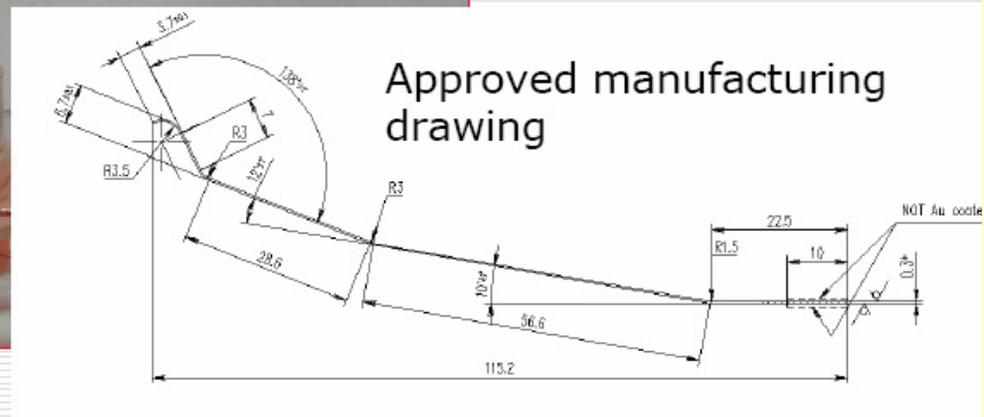
One of the possible causes

QQBI.26R7 V1 bending angles out of tolerance
