Plug-in Modules in 7-8 Status report

P. Strubin on behalf of AT-VAC

Extent of the problem in 7-8

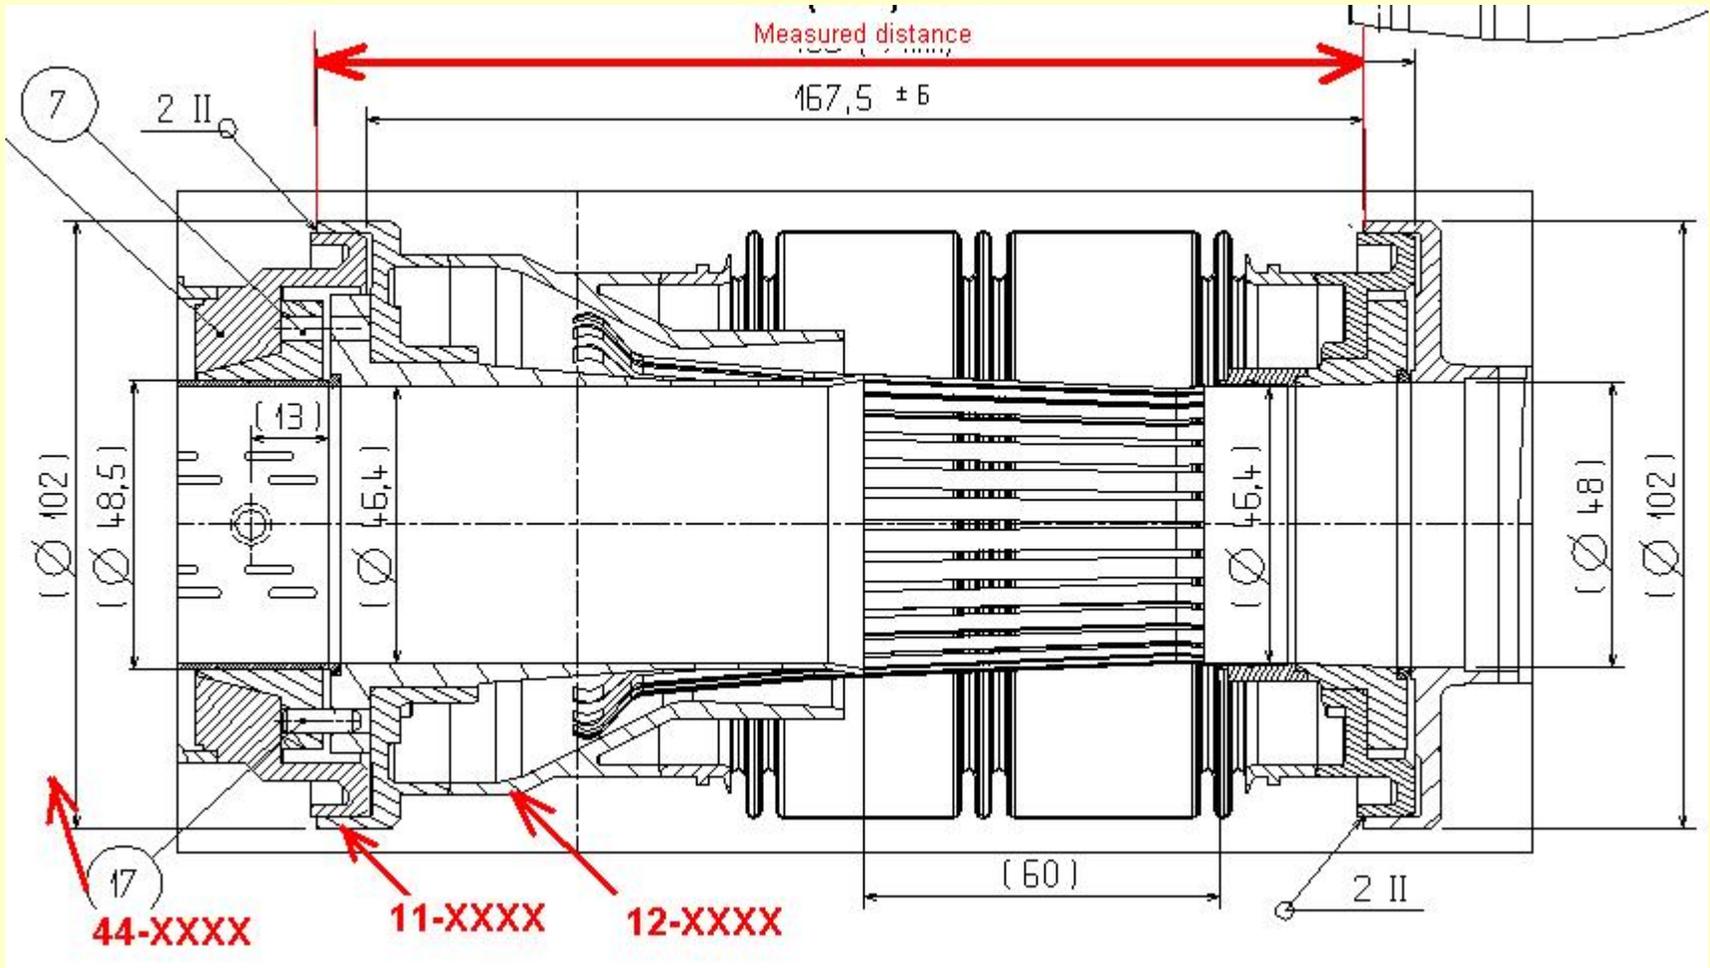
PIM geometry

- o PLANE82 elements, (quadratic, 2-D with thickness, large deformation, linear-elastic material properties)
- o 8 elements through-thickness, 3200 along length (26912 total)
- o Steps:
 - o Model the 'free' shape of one contact finger
 - o Apply a deformation at contact points to produce cold-deformed shape
 - o Read the resultant normal force at contact points
 - o Apply friction coefficient to give lateral friction force
 - o Use this force as input for Eigen value buckling routine on deformed geometry
- o Can vary finger geometry and friction factor to give indications of sensitivity to various factors
